Site Name: <u>Progress Energy Asheville</u>	Date: <u>29 MAY 2009</u>
Unit Name: <u>1964 POND</u>	Operator's Name: <u>PROGRESS ENERGY</u>
Unit I.D.:	Hazard Potential Classification: <u>High</u> Significant Low
Inspector's Name: <u>FREDERIC SHMURAK / JUSTIN STORY</u>

Site Name: Progress Energy Asteville Date: 29 May 2009
 Unit Name: 1982 Pond Operator's Name: PROGRESS ENERGY
 Unit I.D.: _____ Hazard Potential Classification: High Significant Low
 Inspector's Name: Frederic Shmurak / JUSTIN STORY

PHOTOGRAPH LOCATION PLAN
ASH PONDS - PROGRESS ENERGY
ASHEVILLE STEAM ELECTRIC PLANT
SKYLAND, NORTH CAROLINA

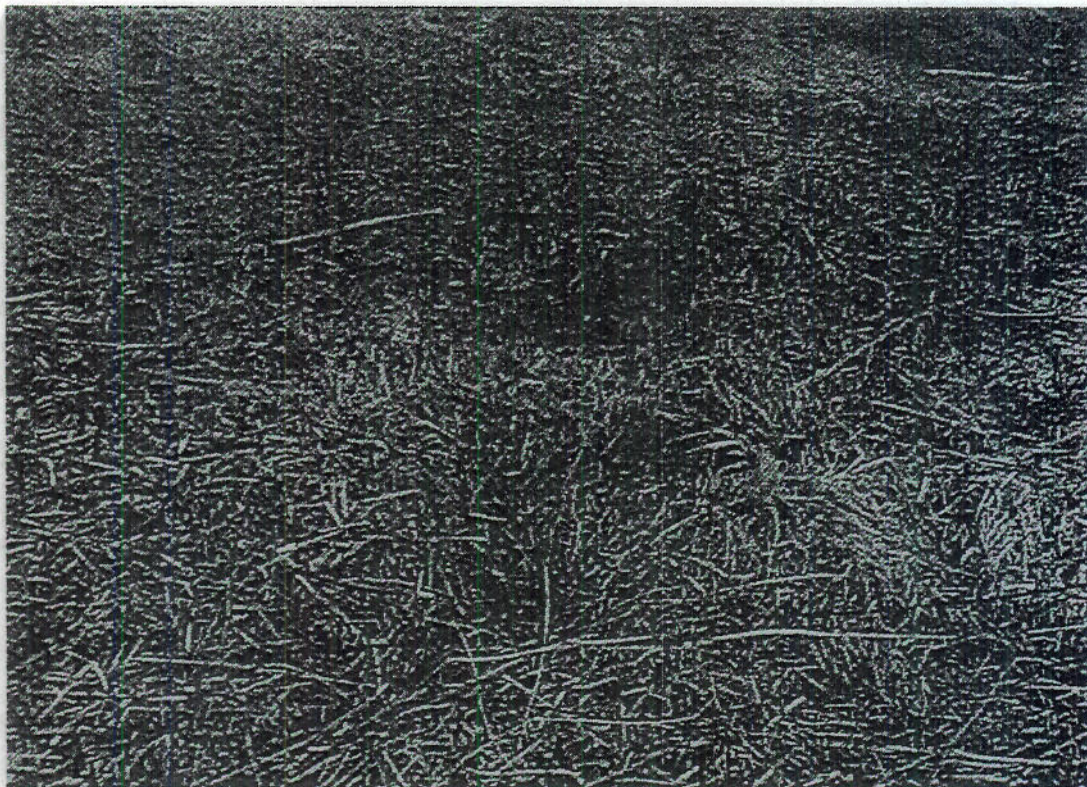
Photograph 6: Cooling Lake Dam - seepage at embankment toe on north abutment, below piezometer P-8, no soil transport noted, orange color from algae).

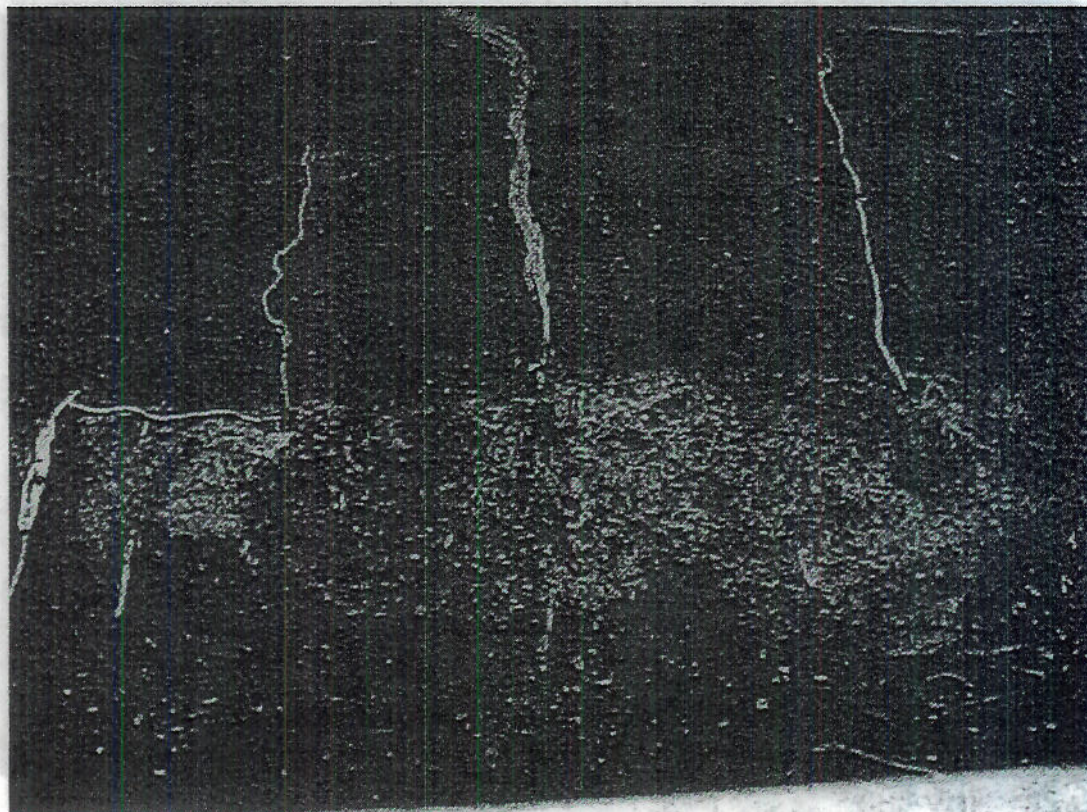
Photograph 8: Cooling Lake Dam – spalling concrete on ogee spillway.

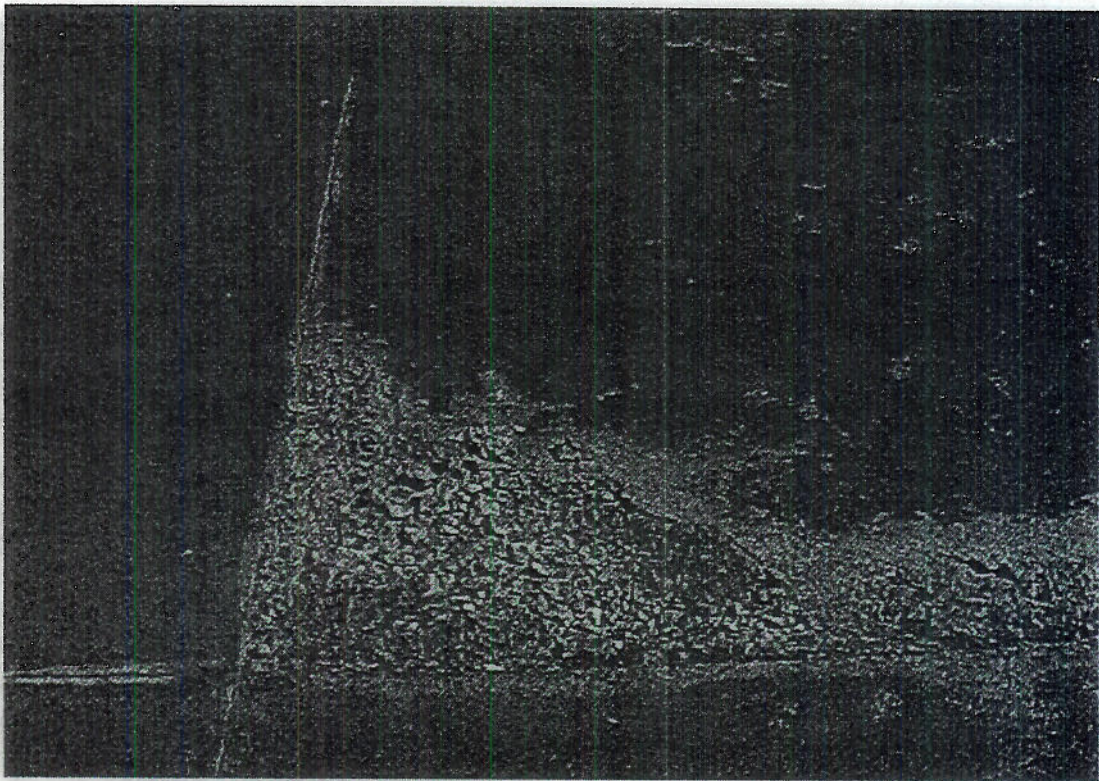
Photograph 9: Cooling Lake Dam – spalling concrete in spillway slab.

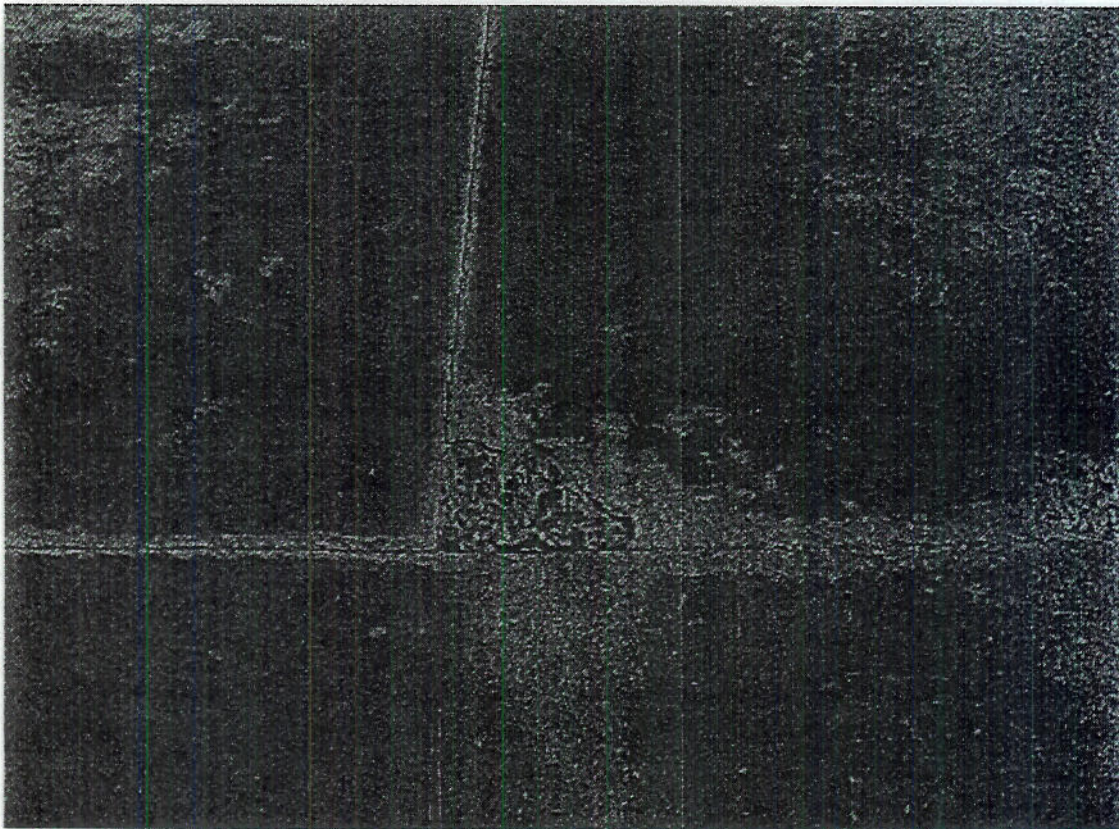
Photograph 10: Cooling Lake Dam – spalling concrete in spillway slab.

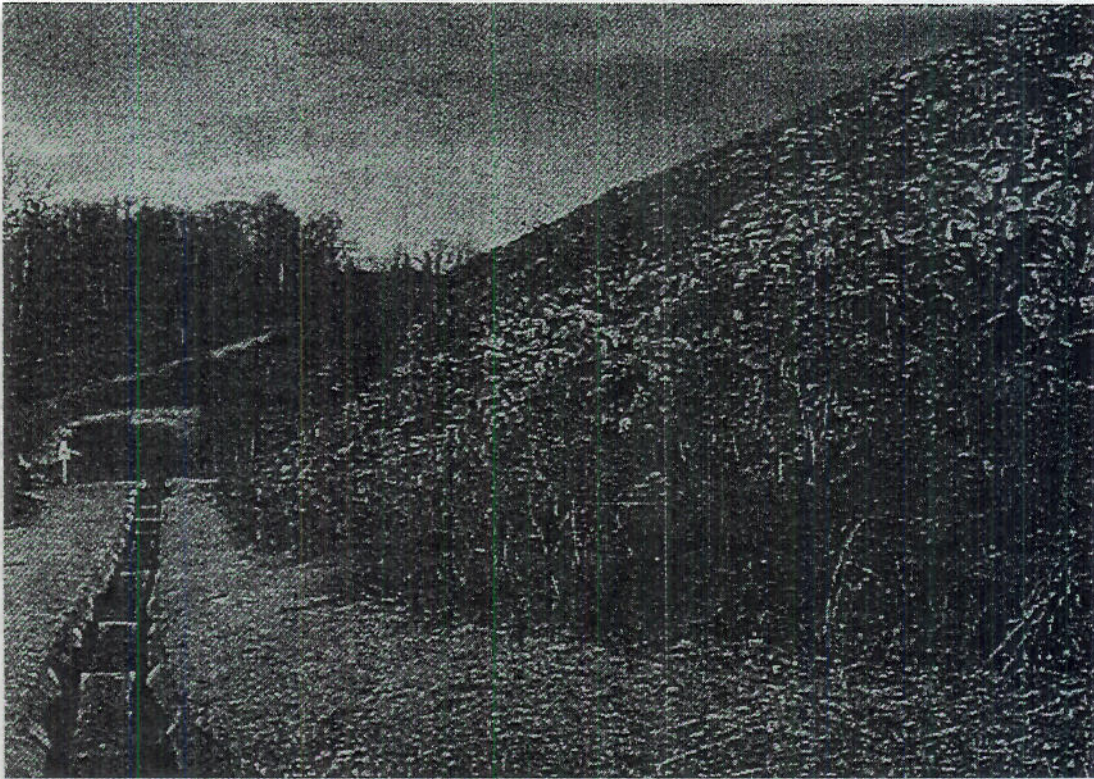
Photograph 13: 1964 Ash Pond – downstream slope looking northwest along toe of slope, note bushes growing in riprap.

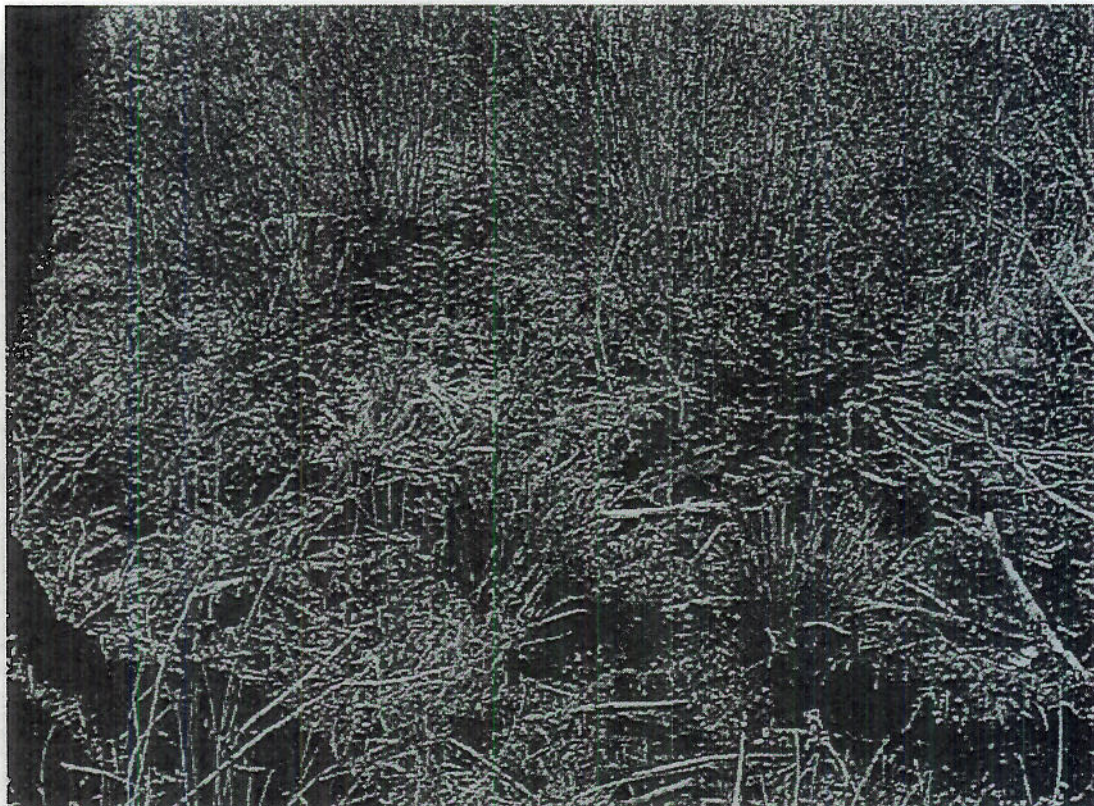
Photograph 14: 1964 Ash Pond – seepage at toe of embankment, north of stilling basin.

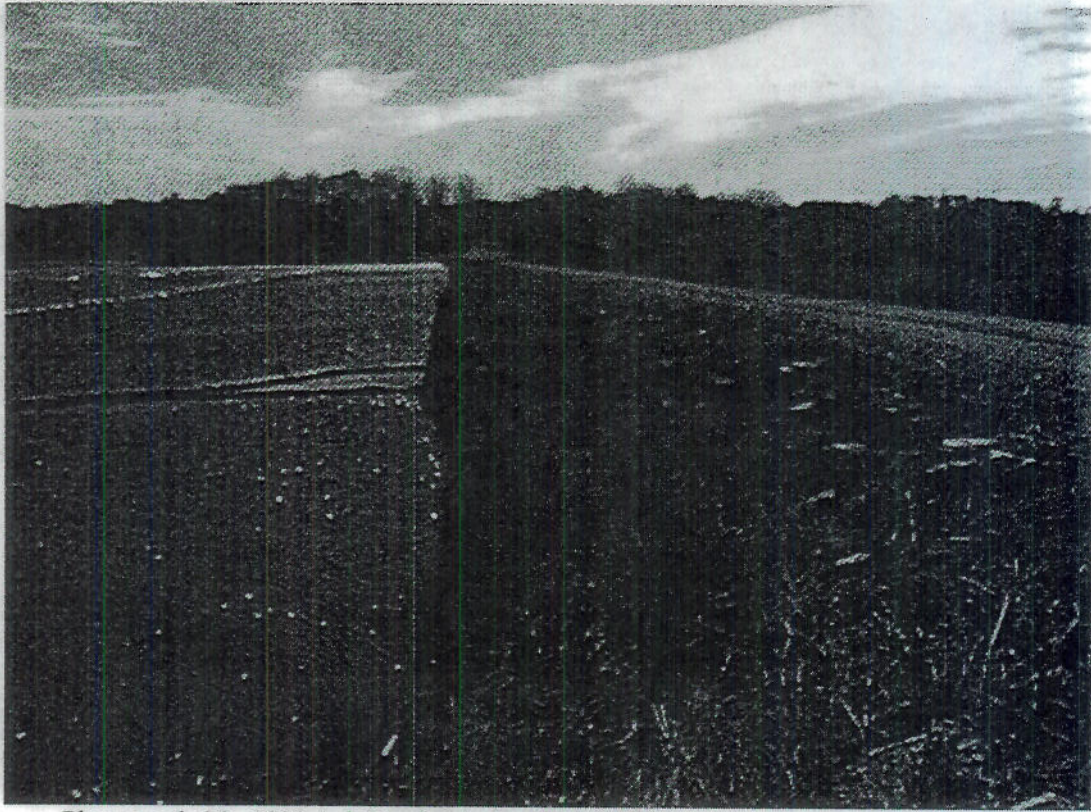
Photograph 15: 1982 Ash Pond, interior slope looking east, note vegetation in riprap.

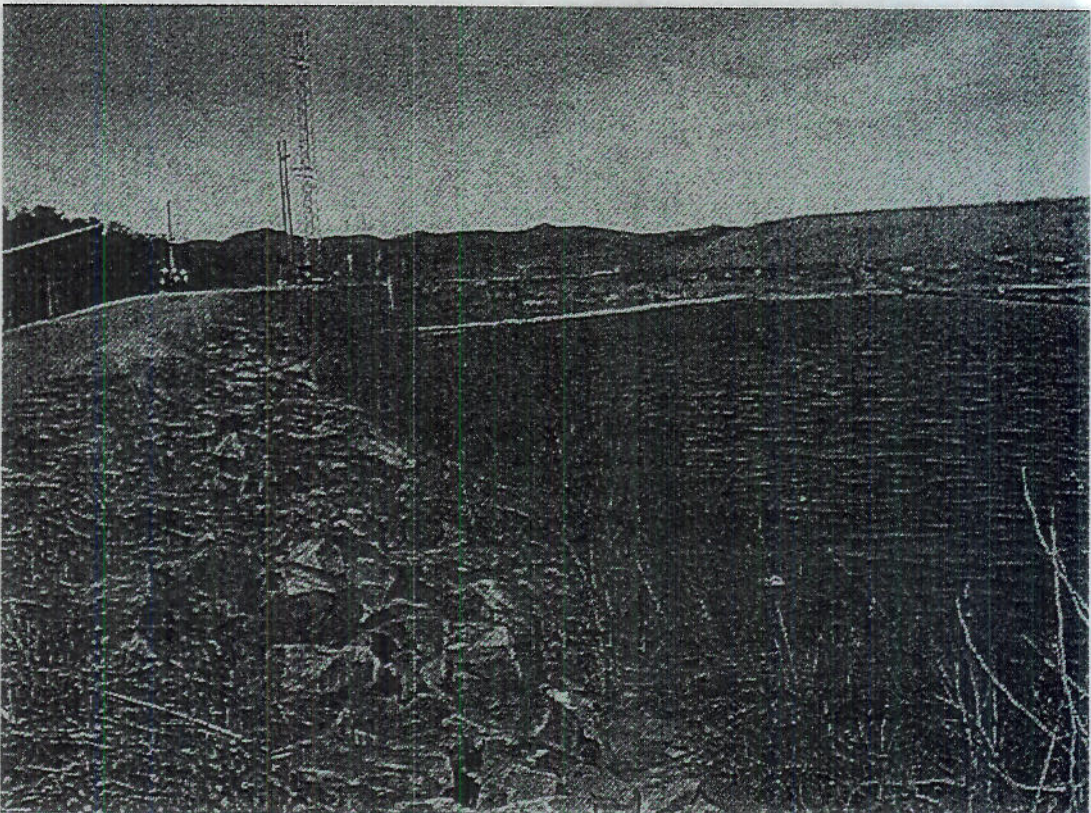
Photograph 16: 1982 Ash Pond - interior slope looking west, note vegetation in rip rap.

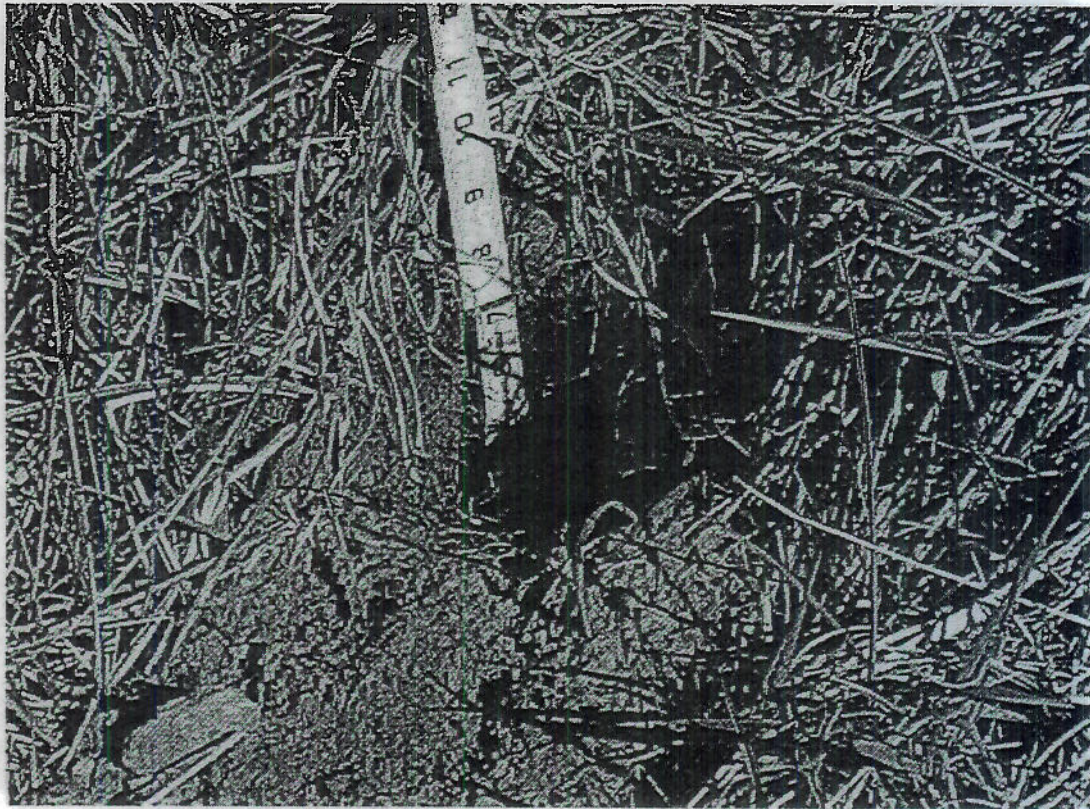
Photograph 19: 1982 Ash Pond – rodent holes in downstream slope.

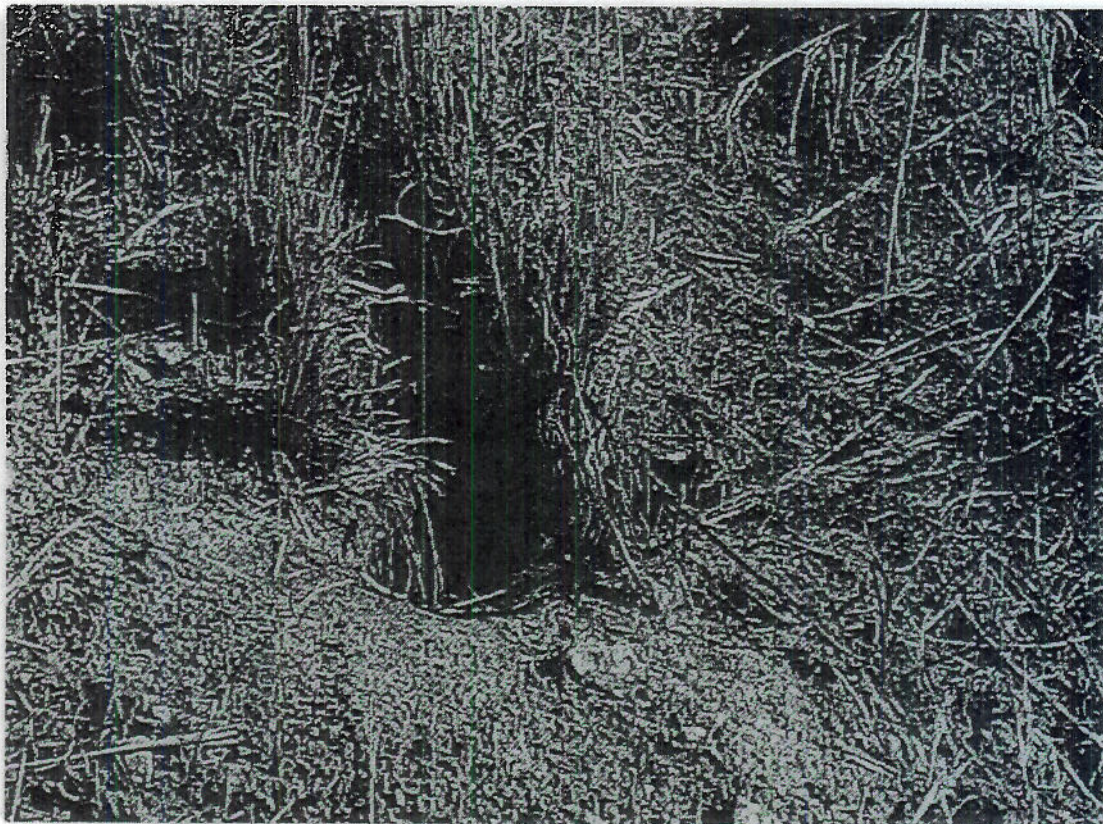
Photograph 20: 1982 Ash Pond – rodent holes in downstream slope.

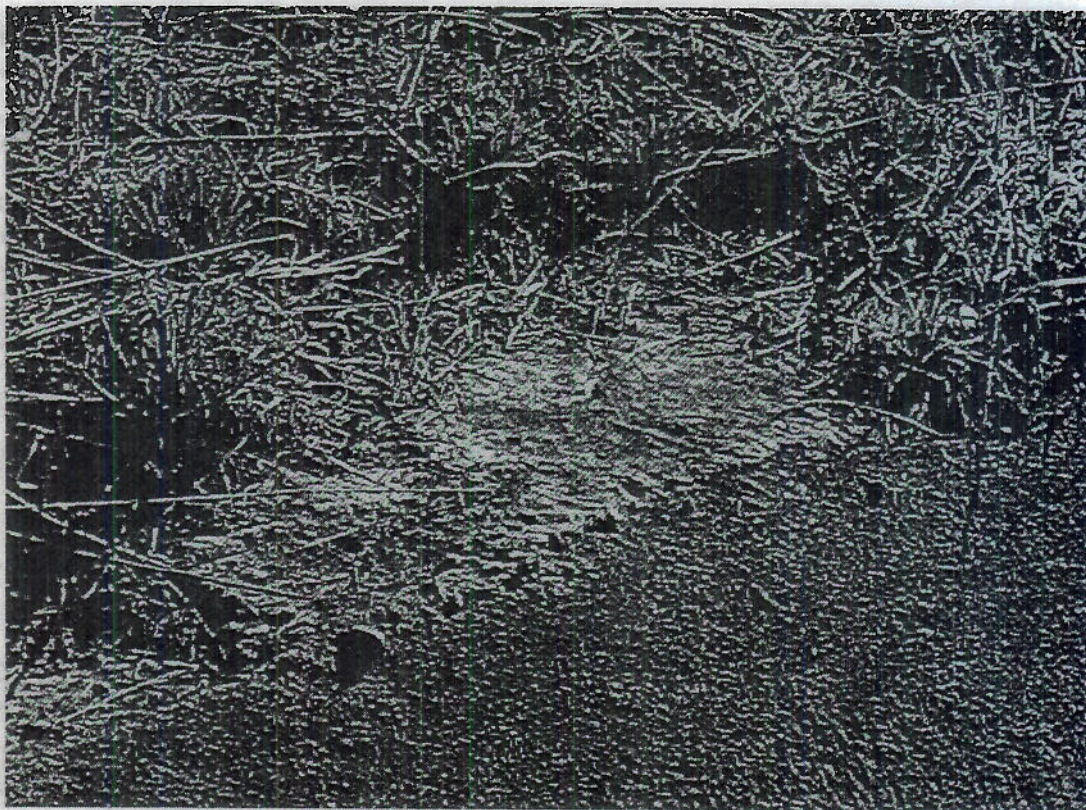
Photograph 23: 1964 Ash Pond – concrete patch at soil/concrete flume interface.

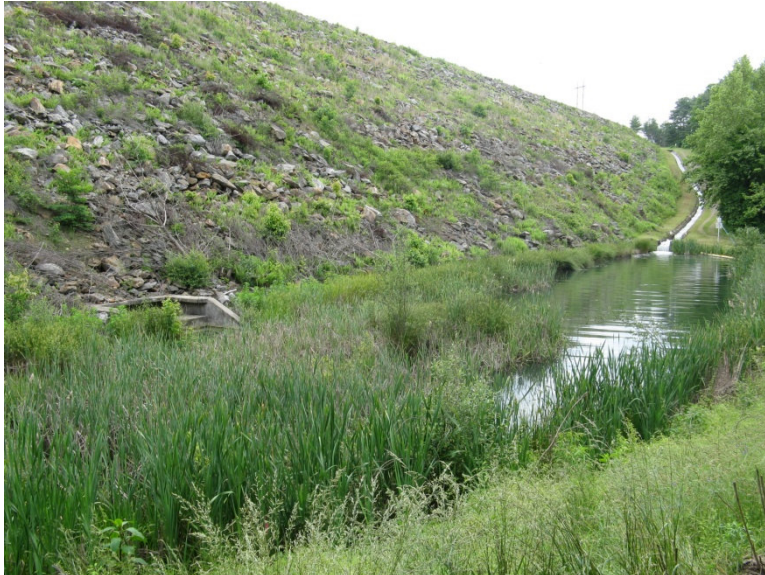
Photo 6: 1964 Dam - Concrete Flume Deterioration, Right Groin, Photo: 090, 5/29/09
(note: right and left are based on the observer facing downstream)
